Laguna Verde RECIRC Pump Discharge Valve Damage

Steve Gallogly
QUG 2014

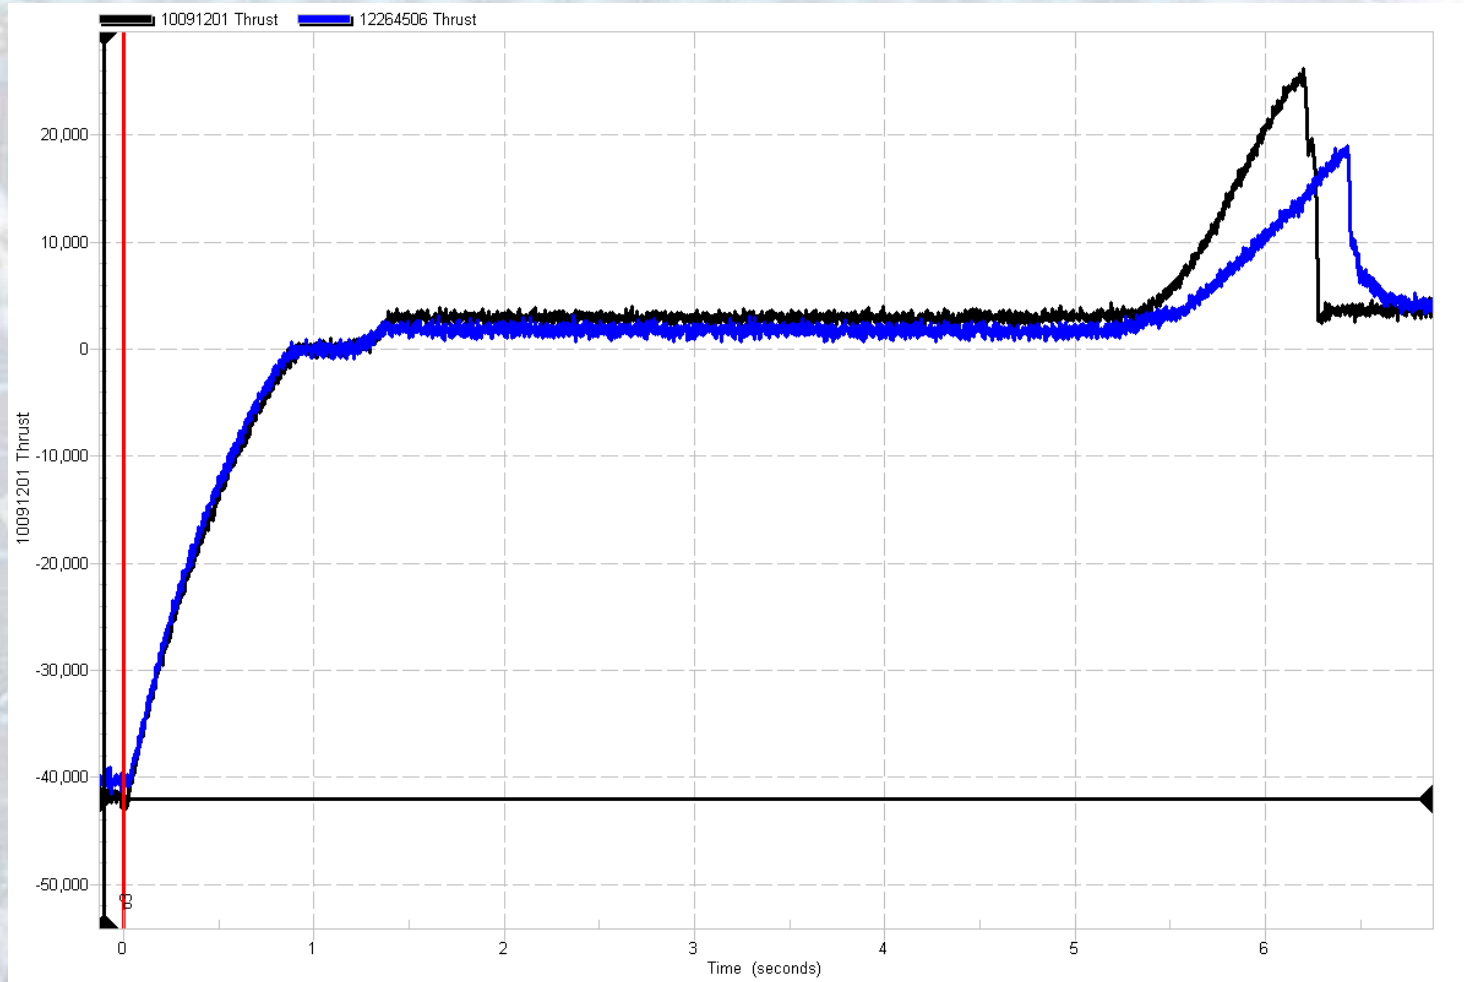
Unit 1 Valve Trend for One Cycle

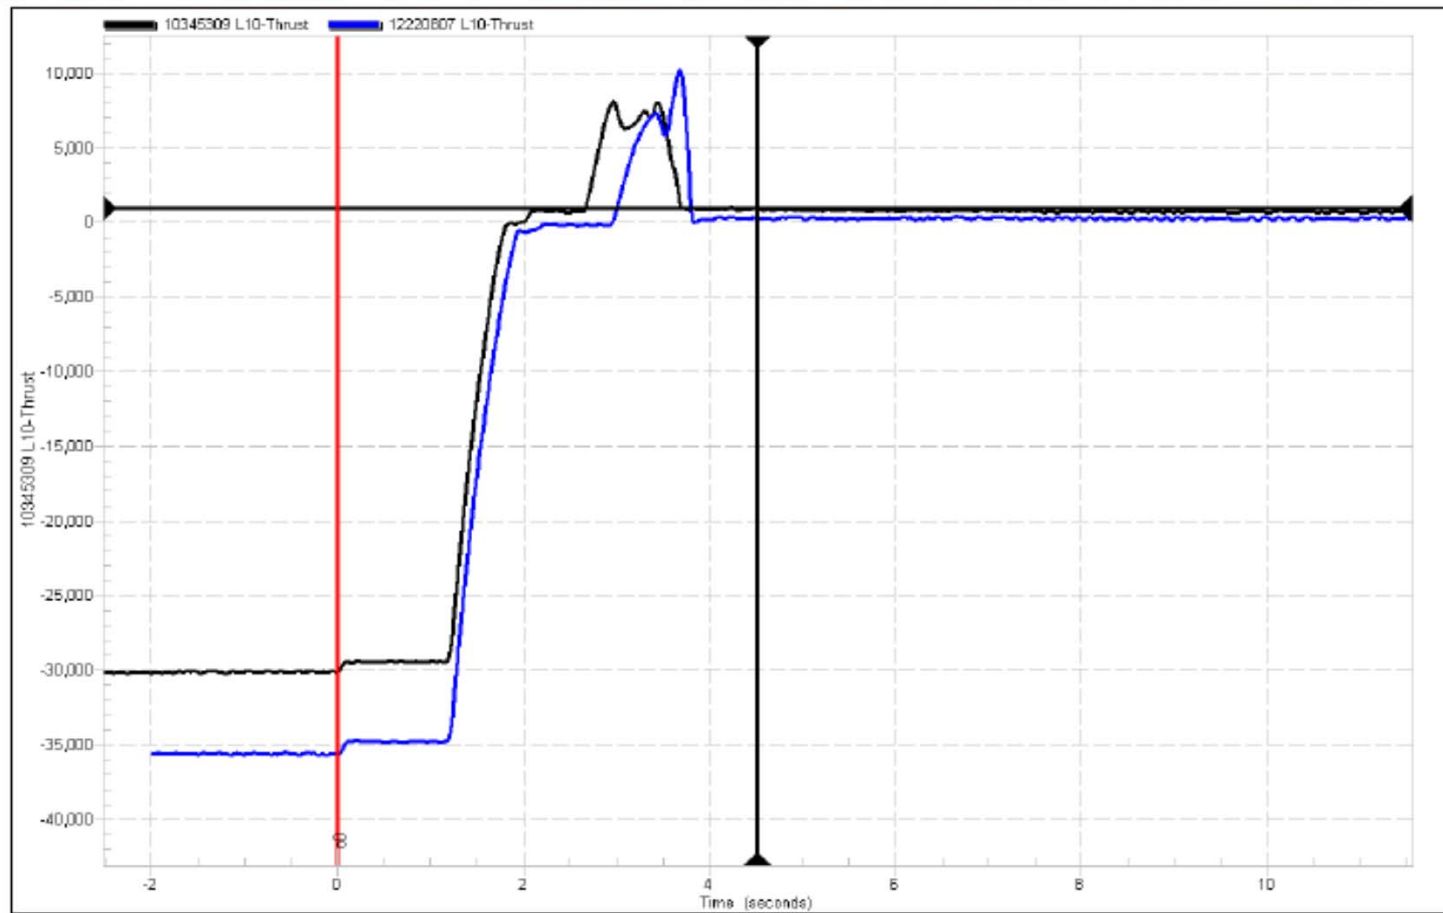
Unit 2 Valve Trend for One Cycle

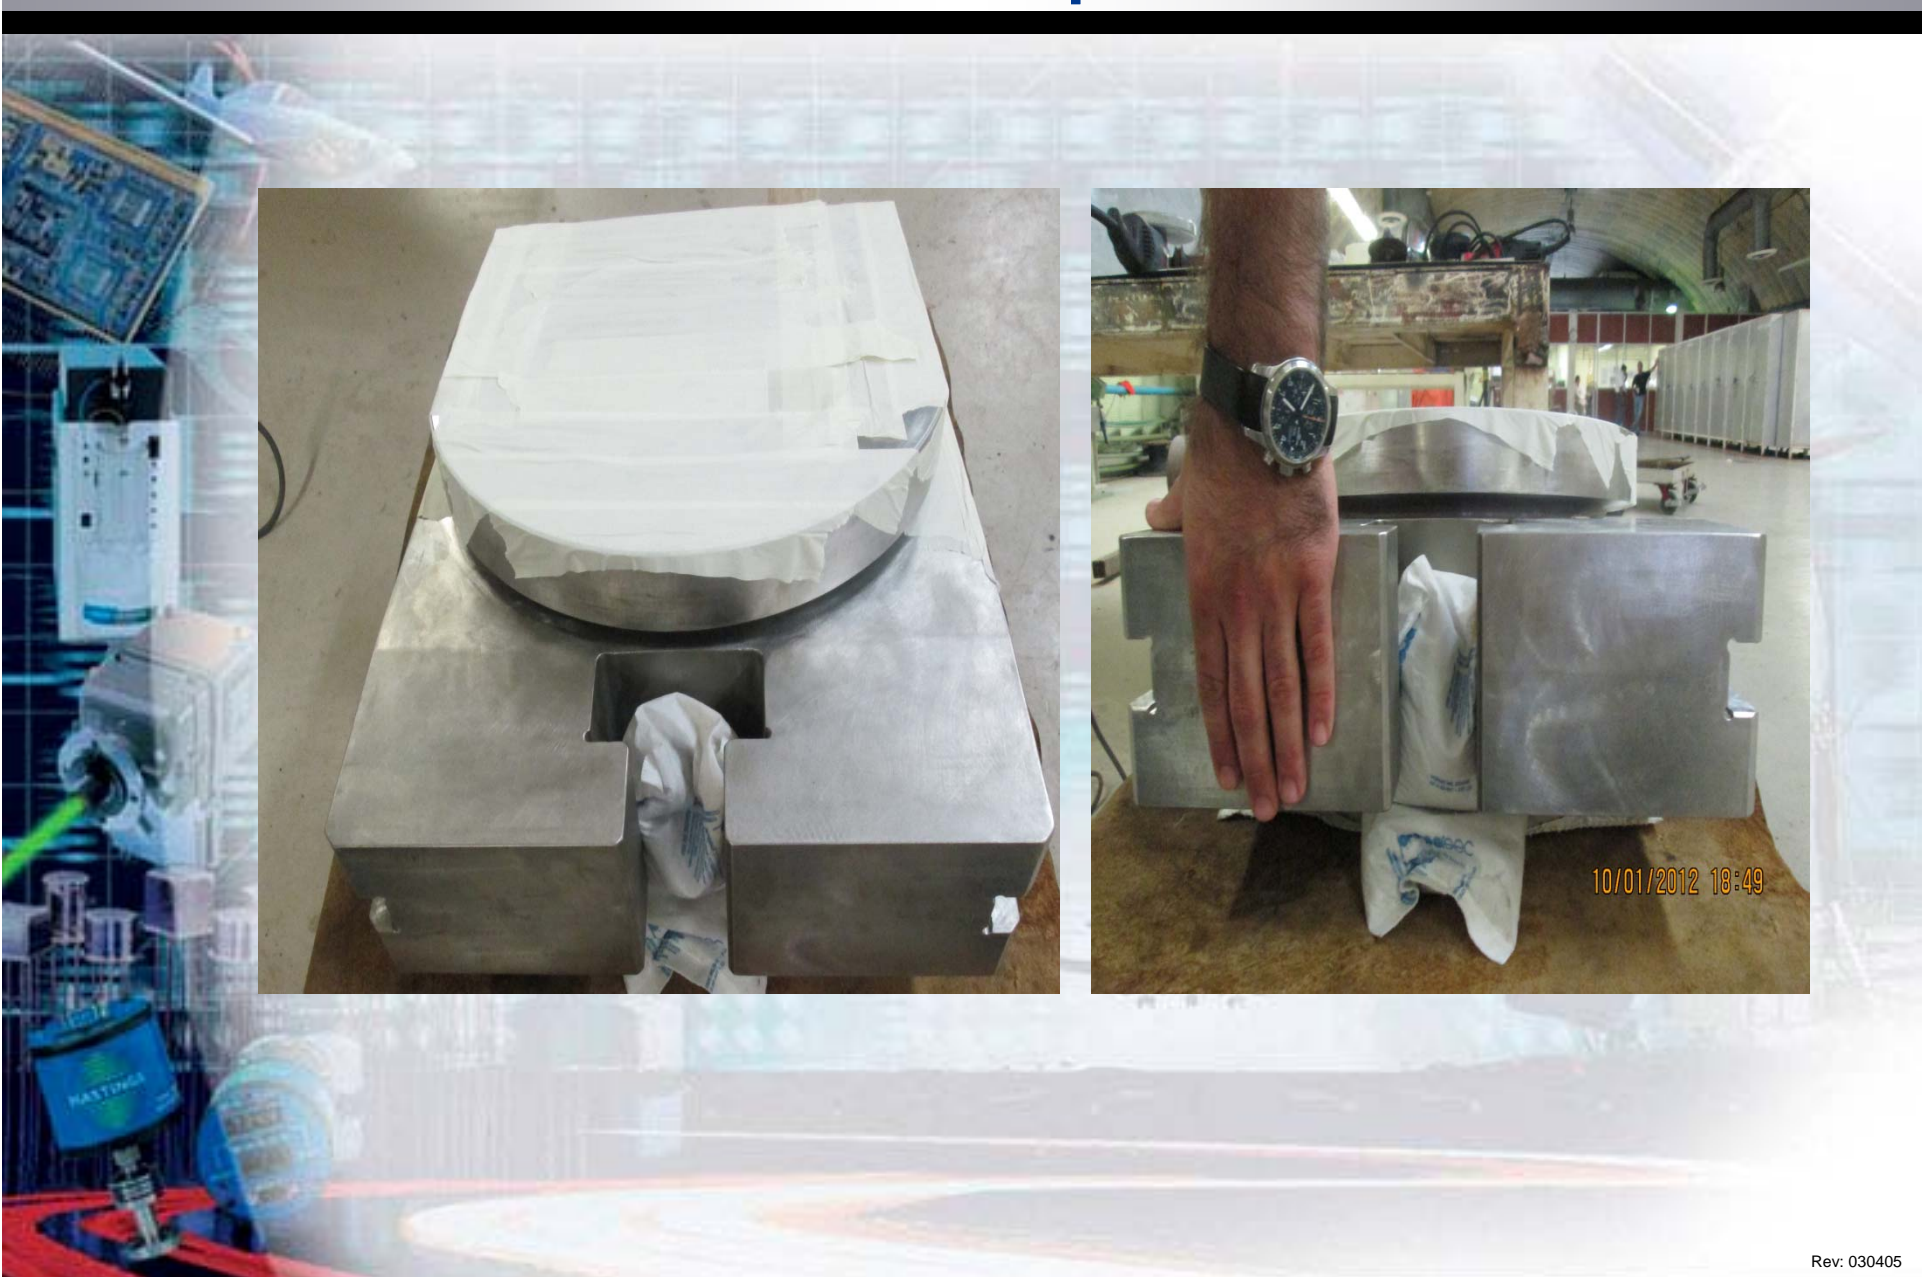
Replacement Valve Disc

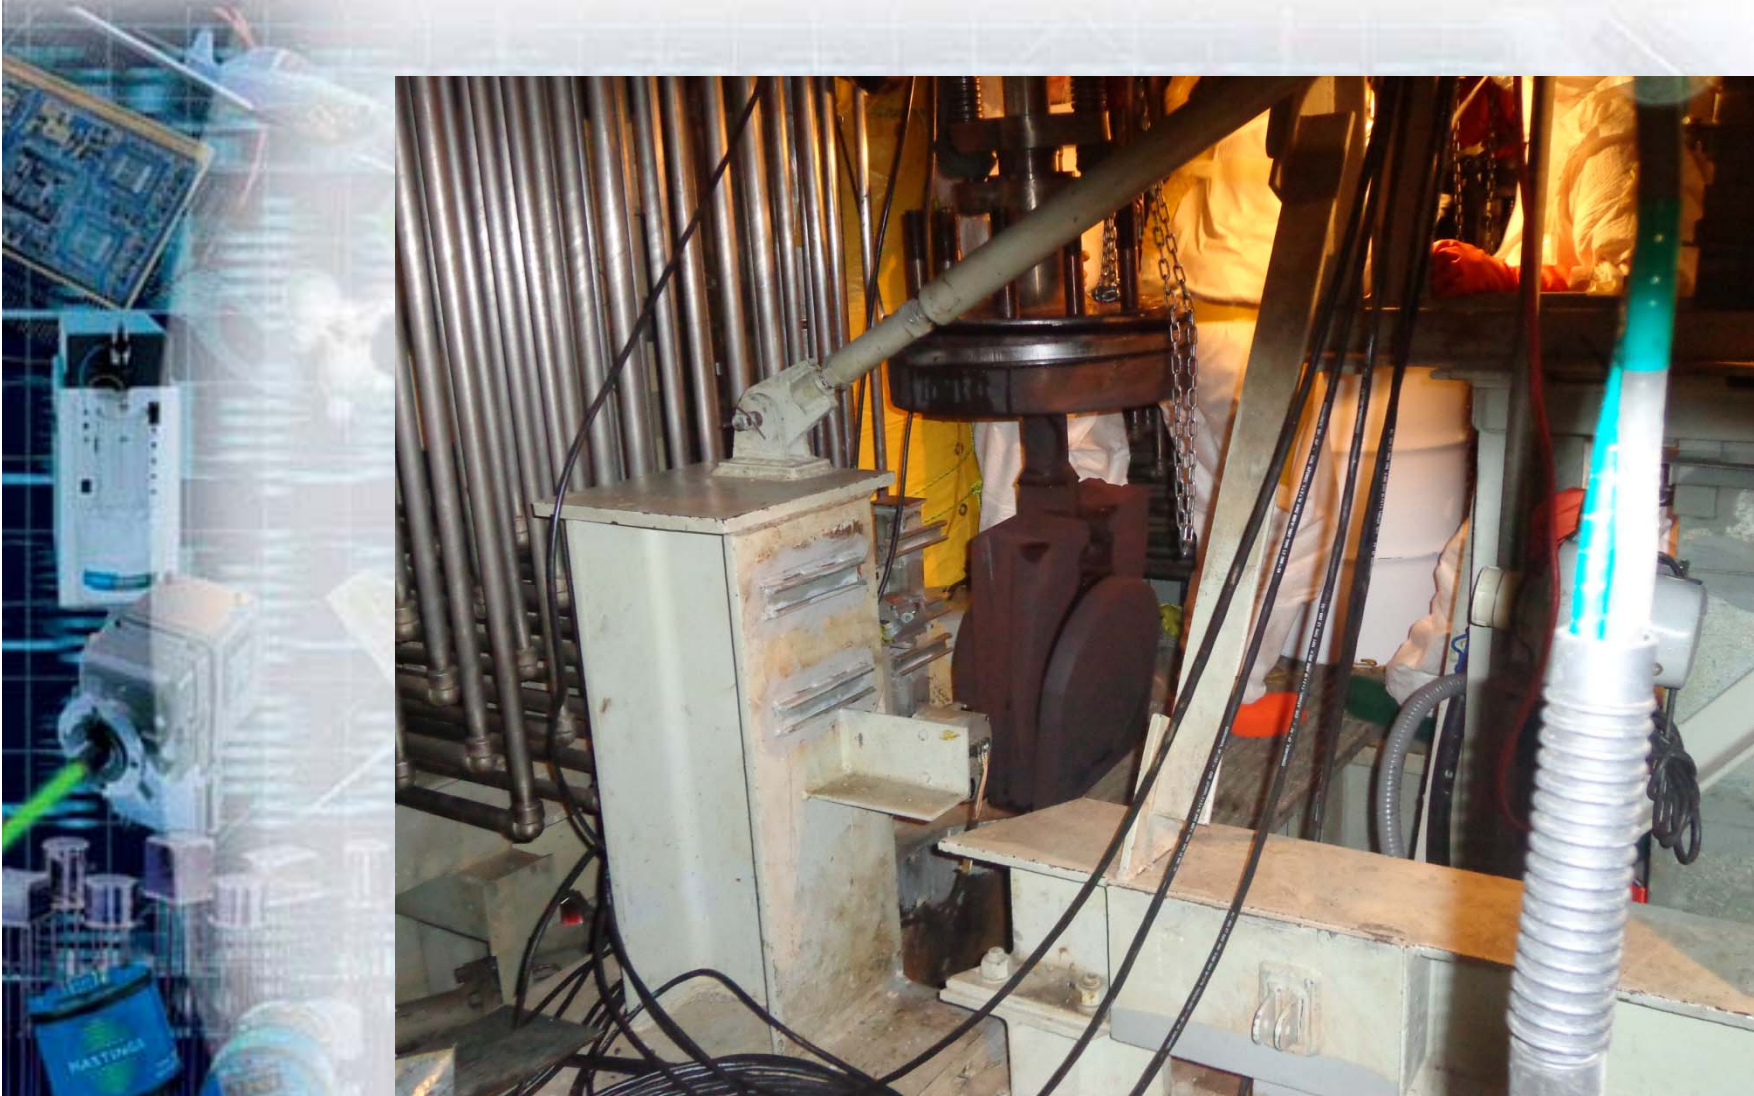
Bonnet and Disc Removal

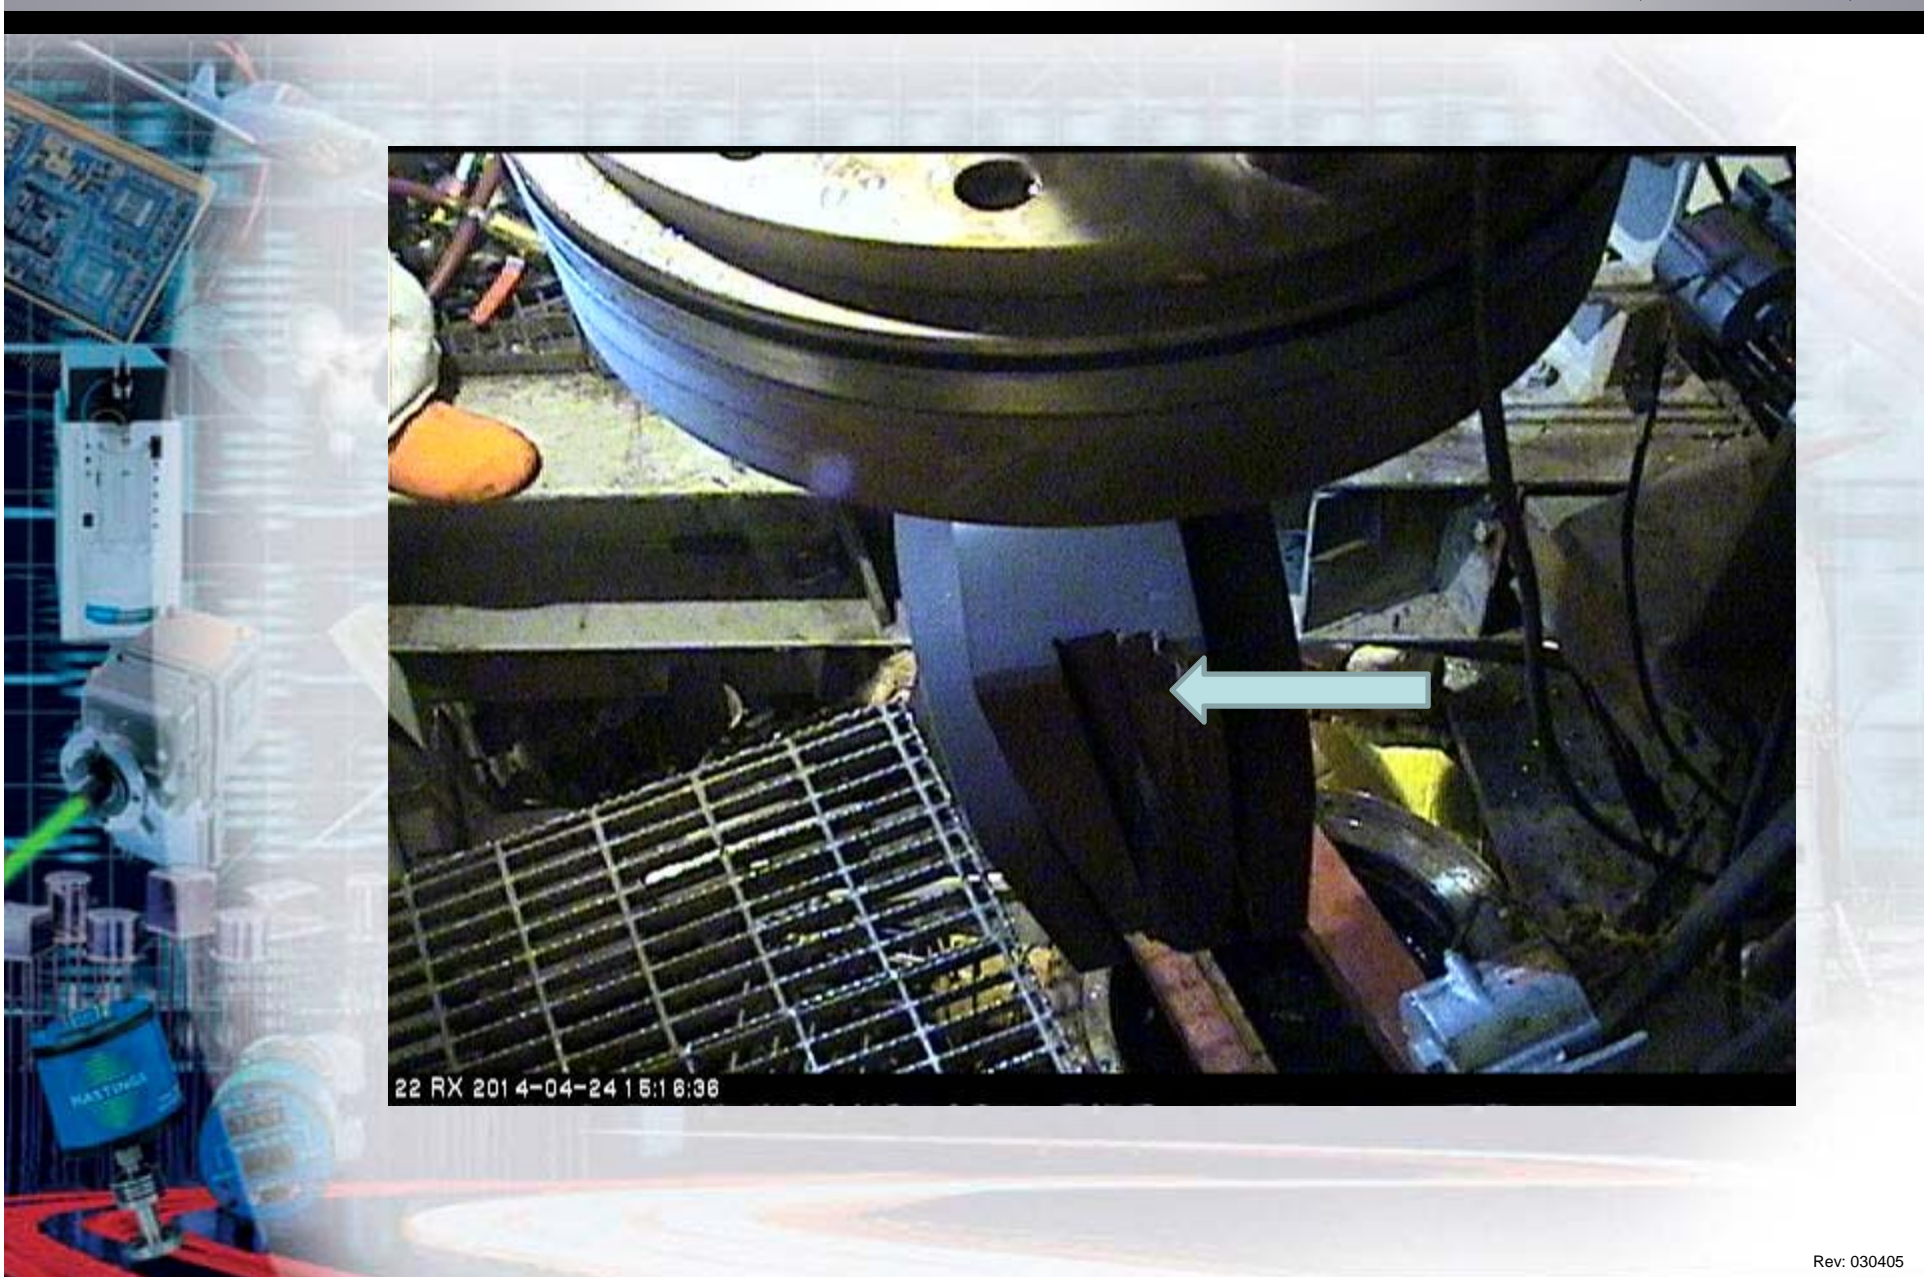
Bonnet and Disc Removal (Cont.)

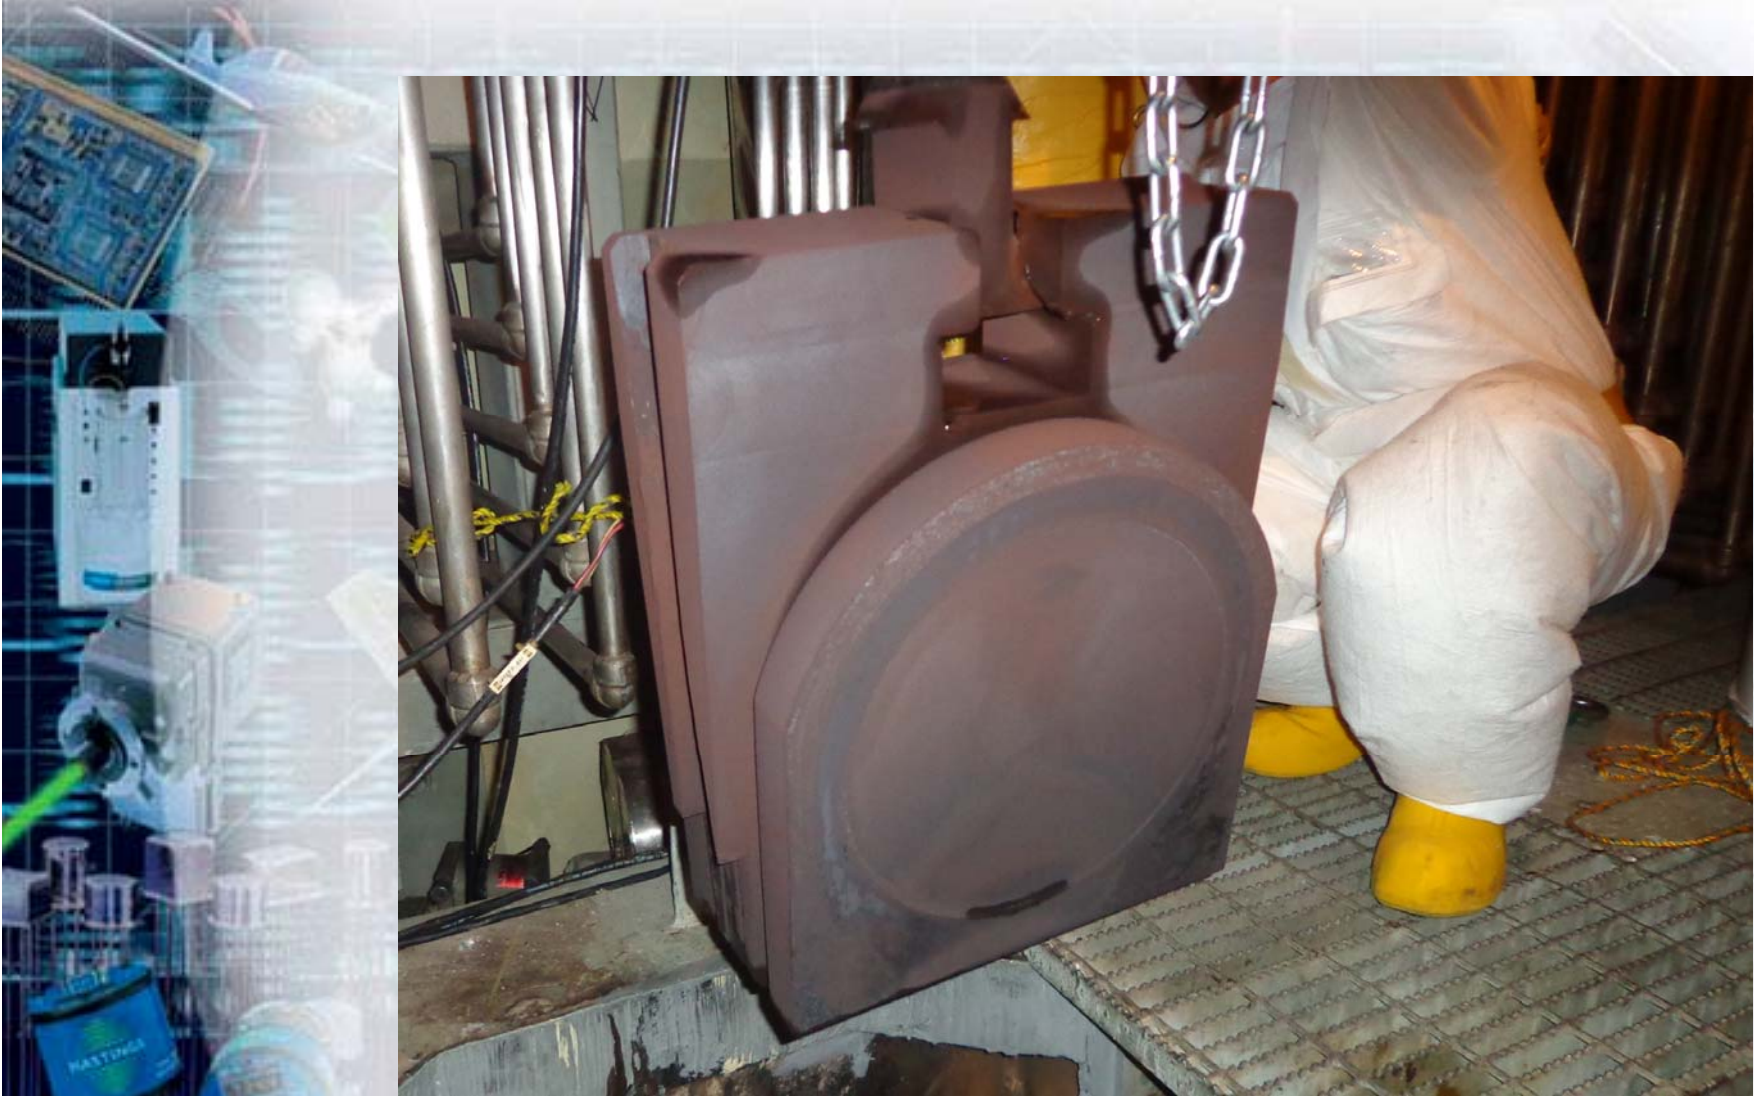
Bonnet and Disc Removal (Cont.)

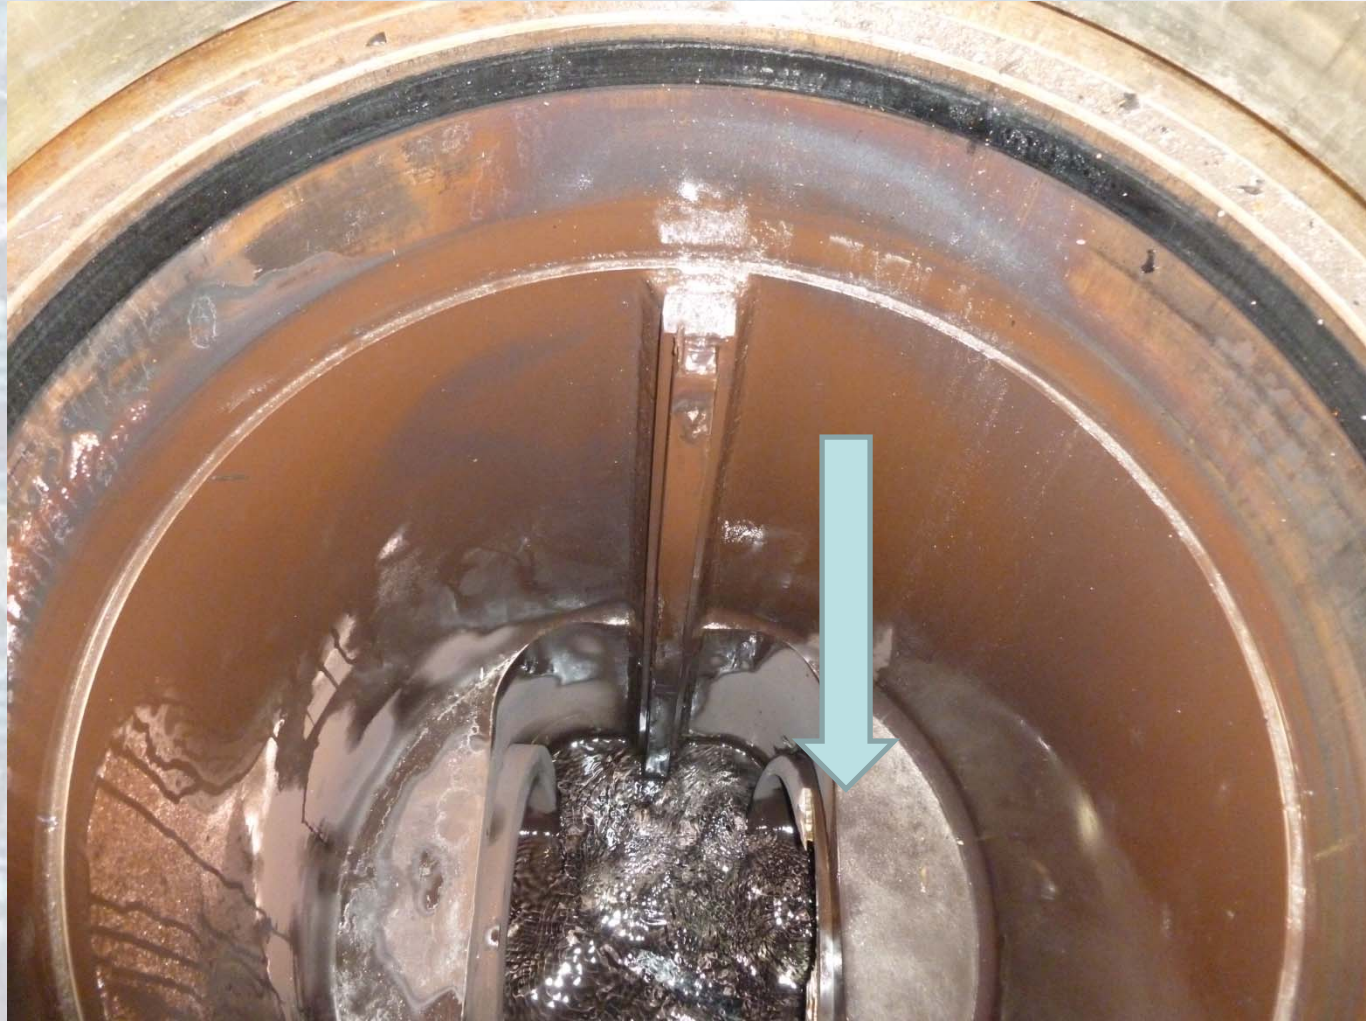
Damage to the RX Side Valve Seat

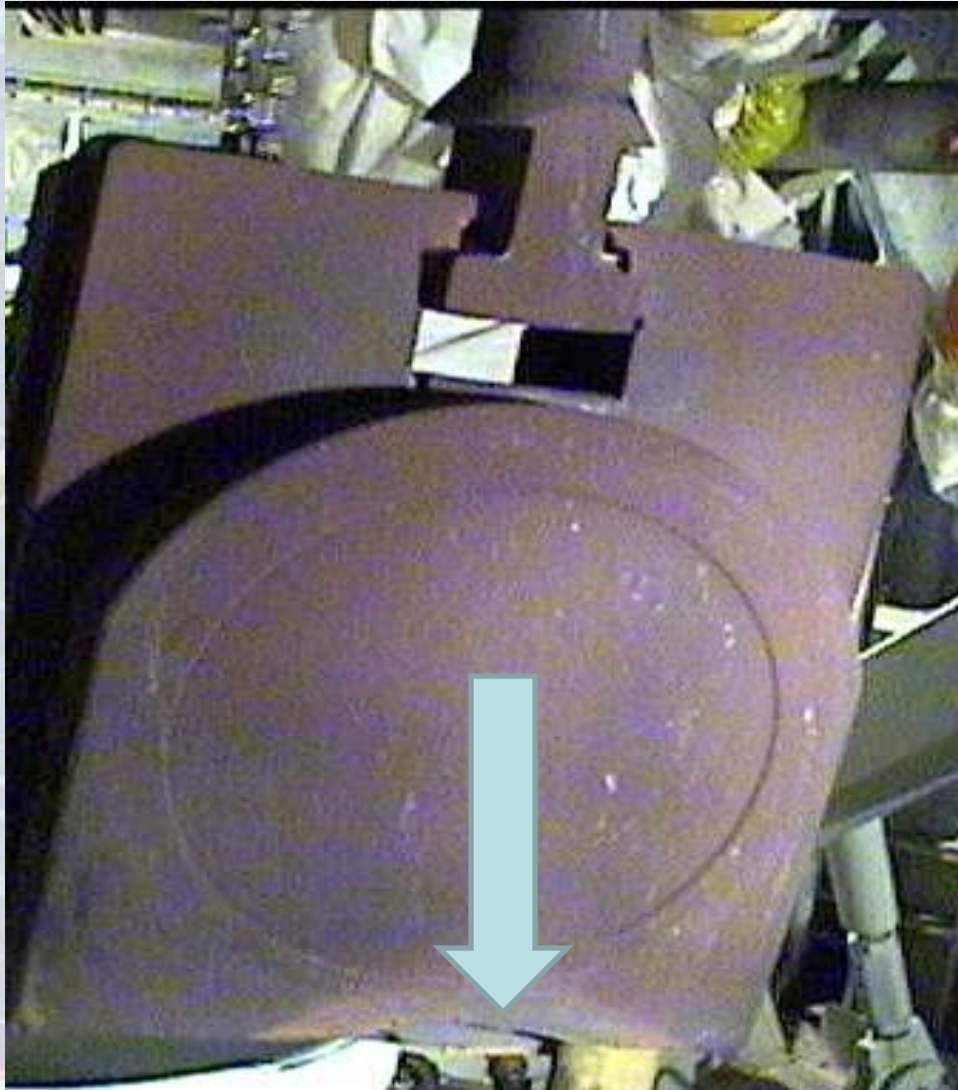
Damage to the Lower Edge of the Disc

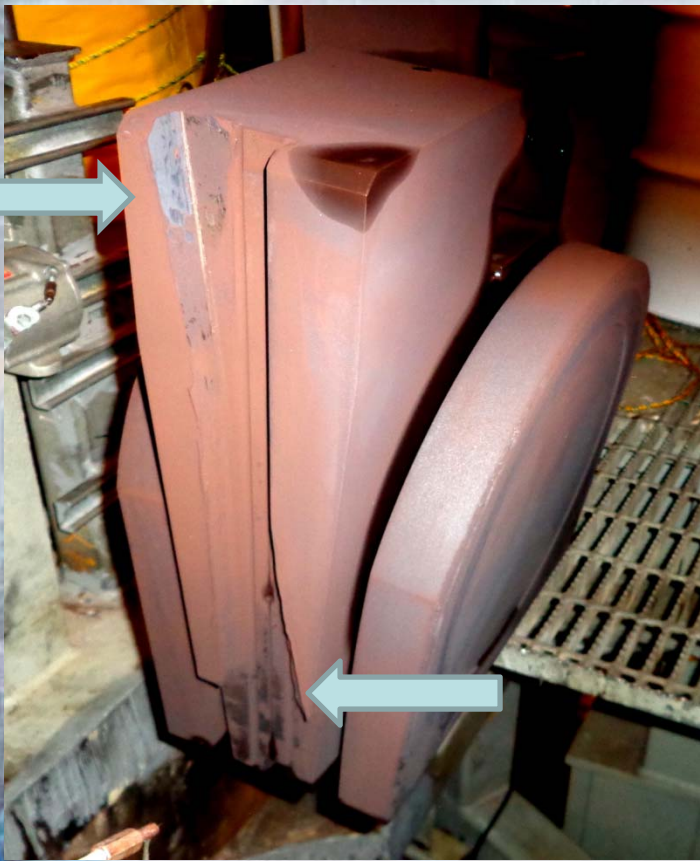
Damaged Disc Guides

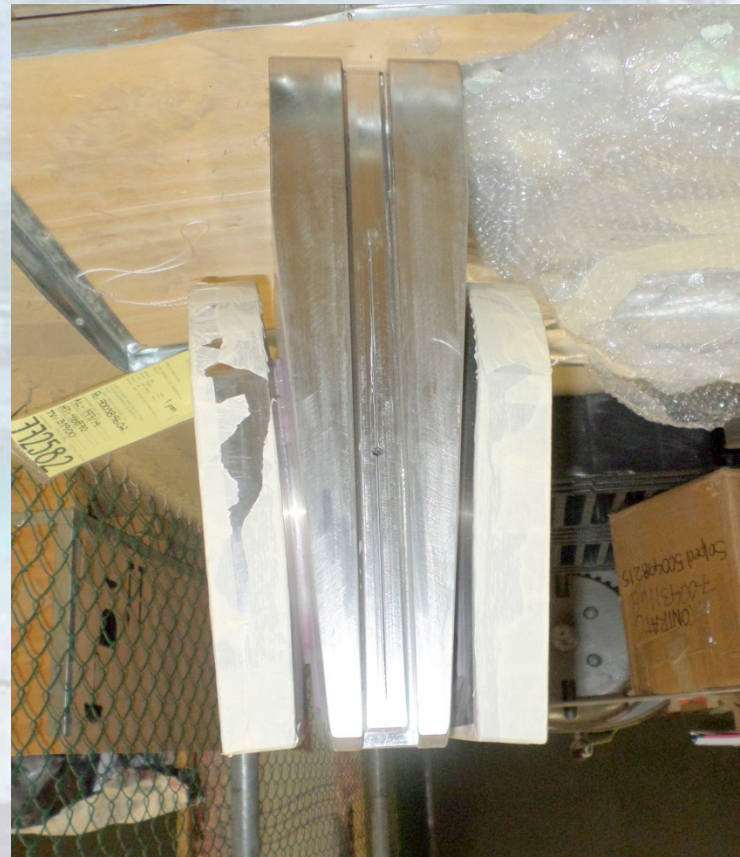
New Disc Guides

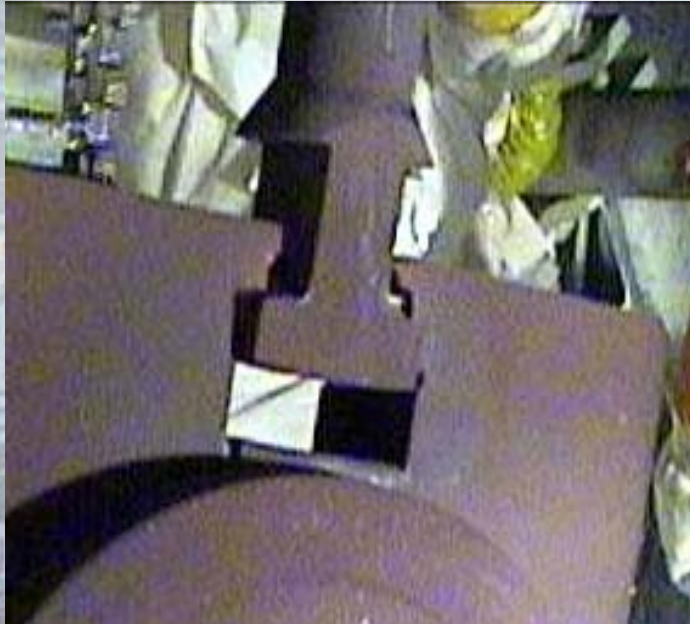
T-Head RX Side

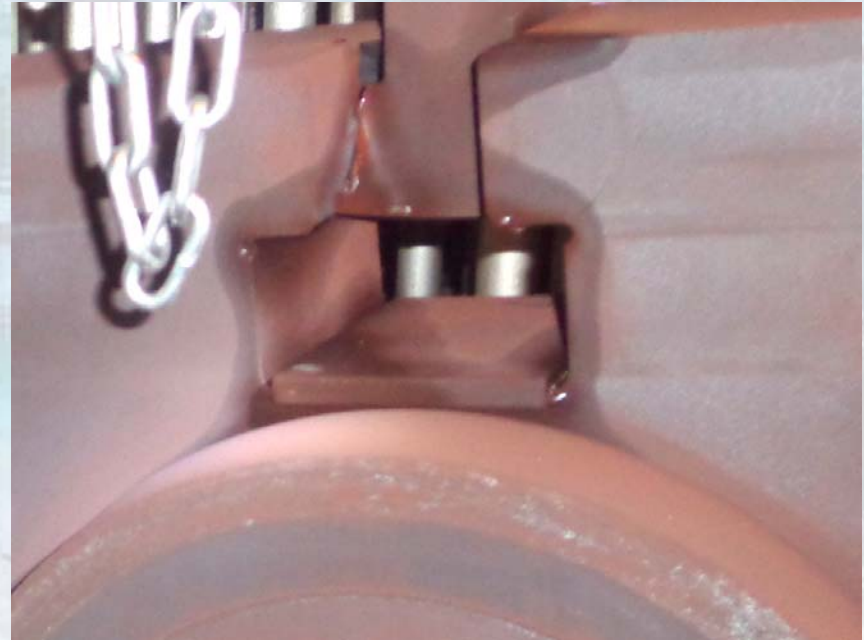
T-Head Pump Side
